Inspection report for the property at
949 New Haven Dr., Fond du Lac, WI

This report is prepared exclusively for **Jonathan Birschbach**
Inspected On: **01-21-2025**

Company Information
ACE Home Inspections, LLC
920-410-6682

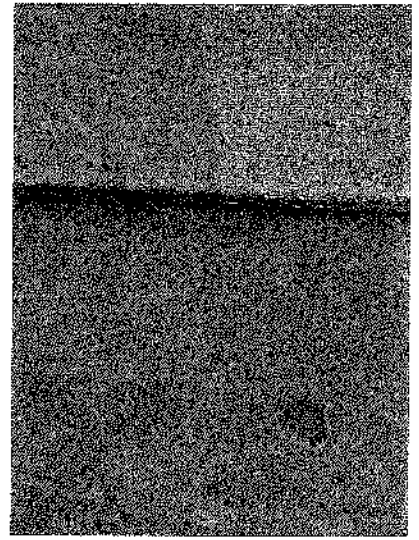
(G-1) Defect:

There are uneven slabs at the front walkway(s), which could be a tripping hazard. Recommend using additional caution in these areas. Repair/replace or mud jack as needed. (Mud jacking involves pumping material underneath a sunken concrete surface to lift it back up to its intended elevation).

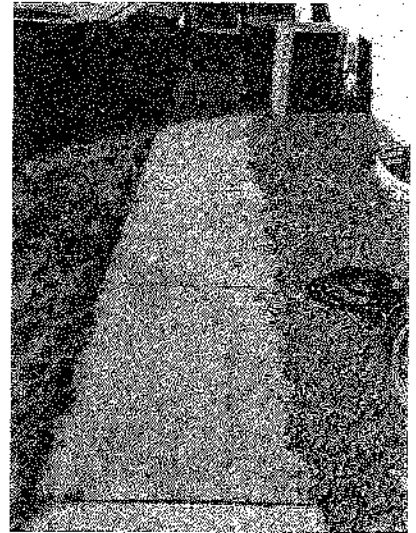
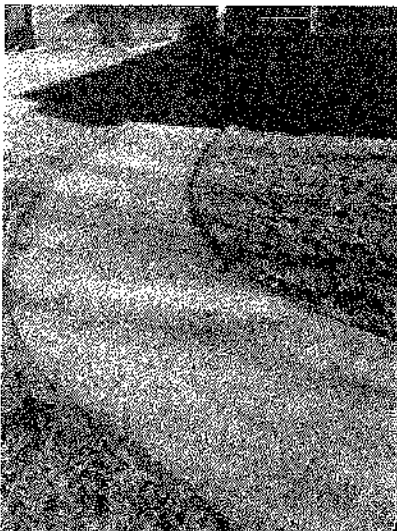
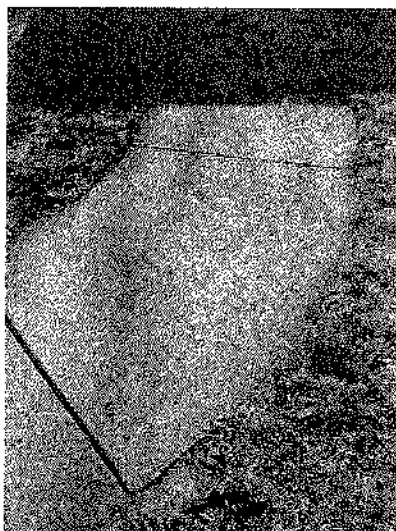
✂ (G-2) Items Needing Repair:

Service walkway is pitched toward the home. Recommend repair.

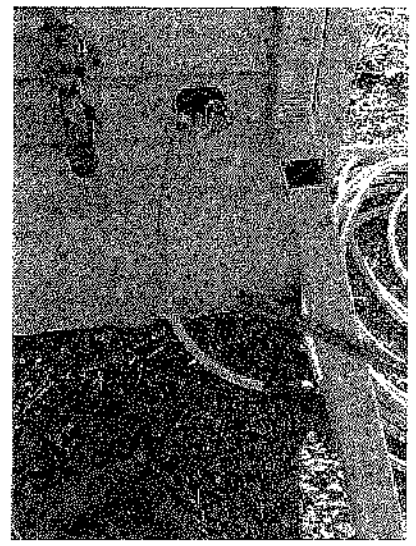
(G-3) Maintenance Item:

Recommend removing the garden hose from the faucet. If you leave a garden hose attached, a small amount of water can stay lodged in the pipe by the spigot and will quickly freeze. This ice can damage your faucet and pipe.

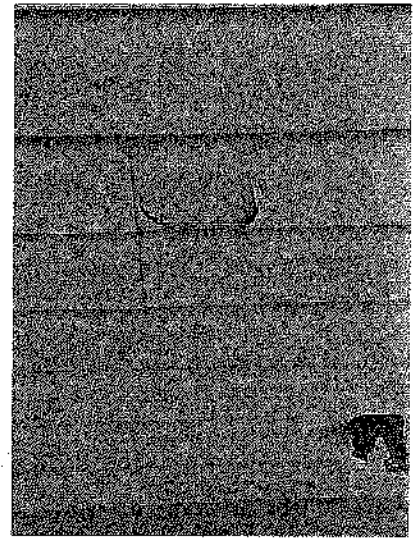
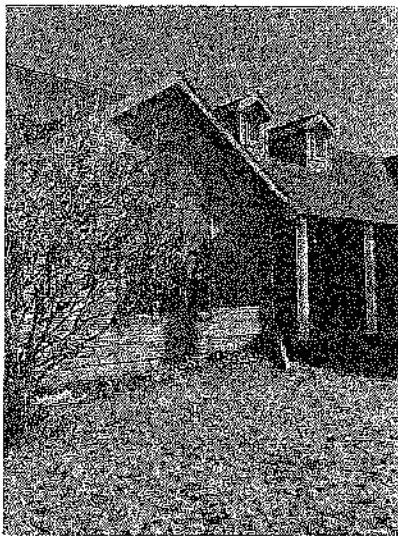
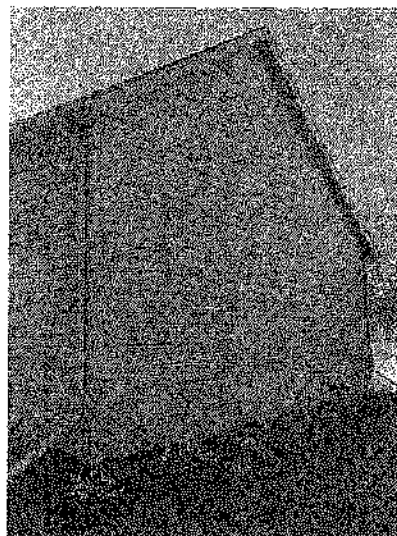
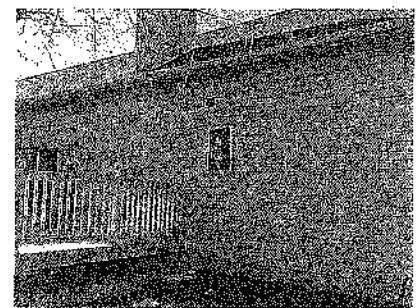
✂ (E-1) Items Needing Repair:

Condition: ☒ Damaged

The siding had some damage in one or more areas. Recommend a qualified/licensed contractor repair/replace damaged siding as needed.

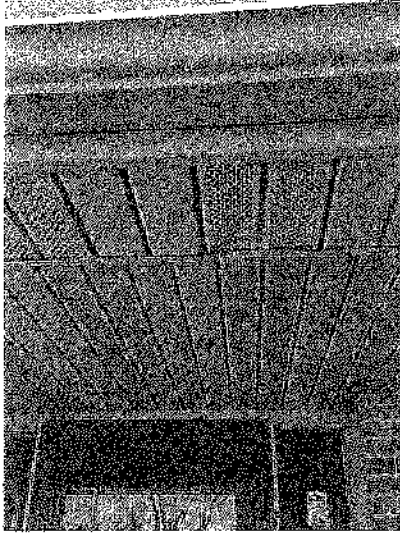
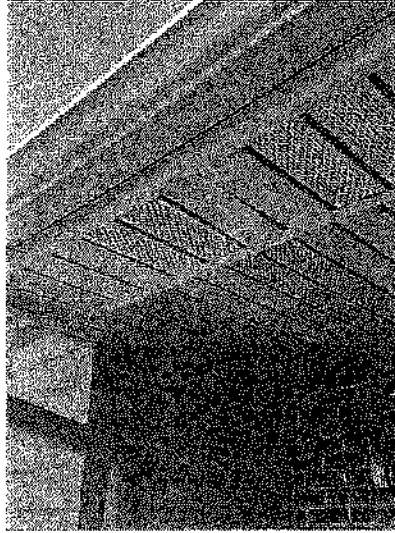
Condition: ☒ Damaged

✂ (E-2) **Items Needing Repair:** The soffit had some holes/damage. Recommend a qualified contractor evaluate and repair/replace any damaged soffit(s).

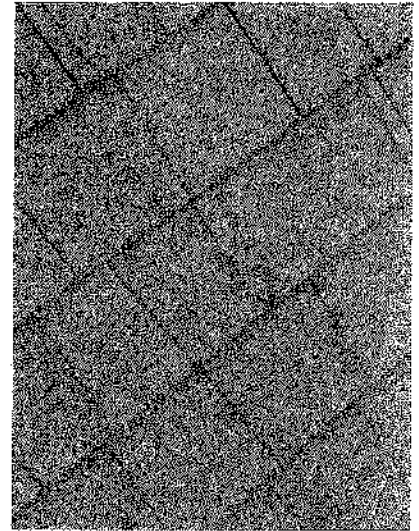
✂ (R-1) Items Needing Repair:

The following conditions were observed while inspecting the roof. Recommend a qualified roofer evaluate and repair/replace the roof as needed.

- Missing granules

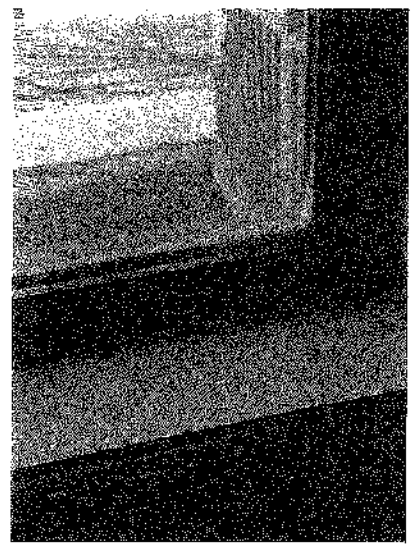
(PB-1) Items Needing Repair:

The window in the bathroom was not operating properly (either they wouldn't open or close smoothly, the sash wouldn't stay open or closed, or some other deficiency) recommend a qualified window contractor evaluate and repair.

Window was froze shut

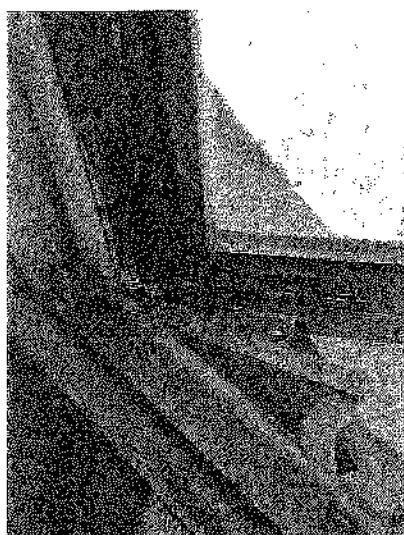
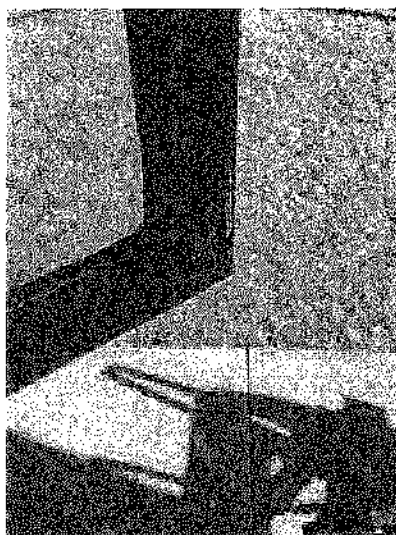
✂ (IM-1) **Items Needing Repair:** Windows in yhe home have moisture staining and rot present. Recommend evaluation and repair as needed.

Example of staining and wood rot

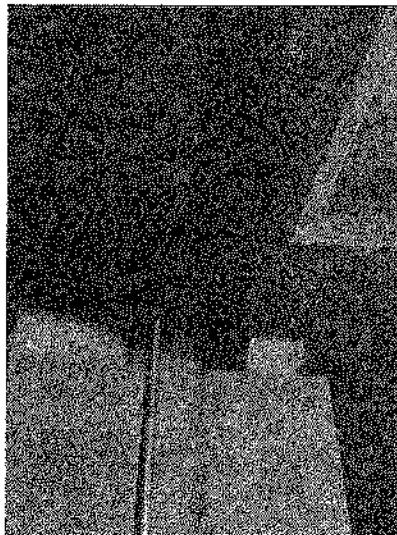
★ Homeowner Information: Hose faucet shut off valve(s)

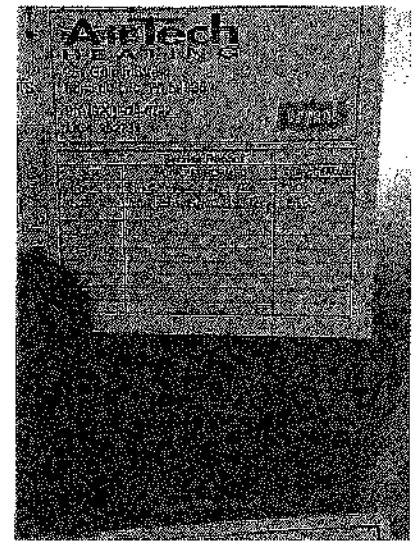
🔧 (H-2) Maintenance Item:

There isn't any indication or documentation that the heating system has been recently serviced. Just like a car, your HVAC system needs regular maintenance (per the manufacturer) to operate at peak efficiency and performance. Regular preventive maintenance also helps to extend the lifespan of your system and can help detect potential problems before they occur, avoiding a costly breakdown or part replacement. Recommend servicing

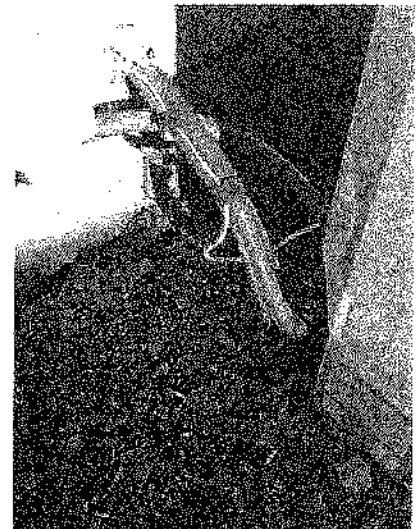
🔧 (C-1) Maintenance Item:

There is worn and/or missing insulation on the air conditioner refrigerant line, recommend replacing the insulation.

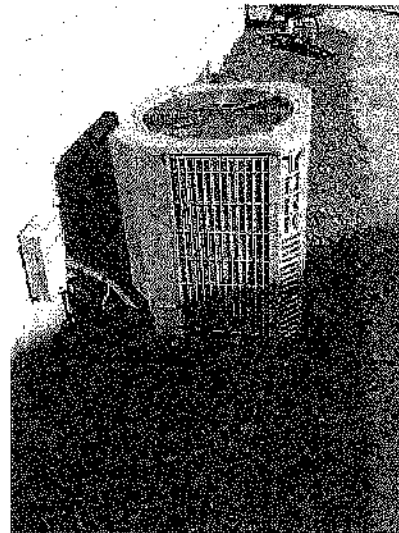
🔧 (C-2) Maintenance Item:

The air conditioner condensing unit wasn't level, for optimal performance recommend the unit be level.

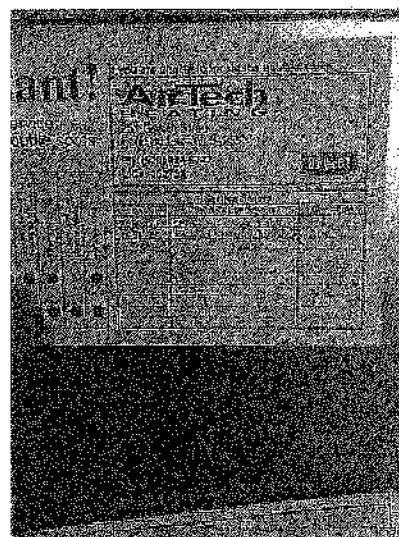
(C-5) Maintenance Item:

There isn't any indication or documentation that the cooling system has been recently serviced. Just like a car, your HVAC system needs regular maintenance (per the manufacturer) to operate at peak efficiency and performance. Regular preventive maintenance also helps to extend the lifespan of your system and can help detect potential problems before they occur, avoiding a costly breakdown or part replacement. Recommend servicing
